TECHNICAL SERVICE DEPARTMENT Technical Service Bulletin 1-800-432-8373

Electric Water Heater Element Failures

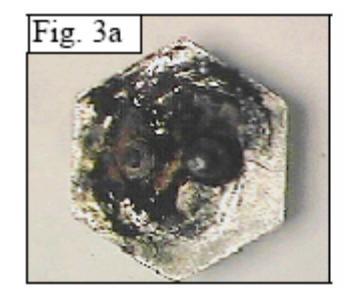
Fig. 2

Dry-fired Elements

A common heating element is designed to operate only when submerged in water. A dry-fired element occurs when the heating element is not submerged in water. Within a matter of seconds, the heating element gets very hot and usually becomes damaged. The nichrome filament wire inside the copper sheath burns in two and the heating element is damaged beyond repair. The copper sheathing becomes very soft (see picture) and easy to bend with your hands due to the excessive temperature applied to the element. You cannot easily bend the copper sheathing of a good element. Notice the melted plastic sleeves (see also Fig. 3b) at the end of the element caused by excessive heat. To prevent dry firing, make sure the heater is full of water before applying power to the unit.

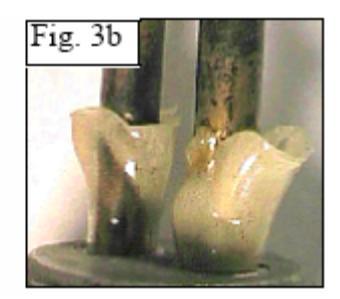
Fig. 3

Power Surge or Lightning Strike

This type of failure does not require a direct hit by lightning, but can also occur as a result of an induced voltage surge from electrical storms in the vicinity. Element has a small crater-like pinhole on the heating element side of the element head. Element will usually have a swollen or split sheath and will often show signs of spalling (a glob of molten sheath that results from the extreme voltage and instantly cools to a small ball-shape). You may also see black soot (Fig. 3a) on the element head near the screw terminals. If it is known that a heater was involved in a lightning strike, all thermostats and elements should be replaced. Notice the melted plastic sleeves at the end of the element (Fig 3b). This is caused by excessive heat.

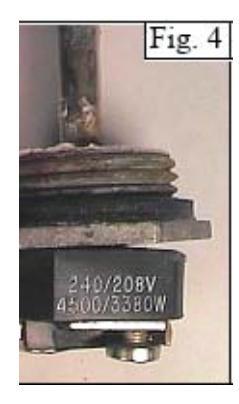
Defective Staking

Fig. 4 Characterized by water leaking through the terminal block. The

element is usually still operable and no sheath damage is evident.

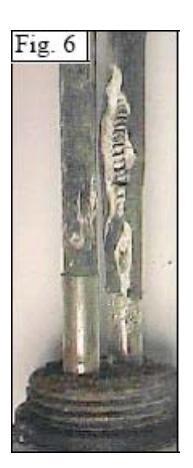
Bad Terminal Weld Fig. 5

Terminals come loose from the terminal pin which may protrude
through the blockWarranty YES⊠ NO□

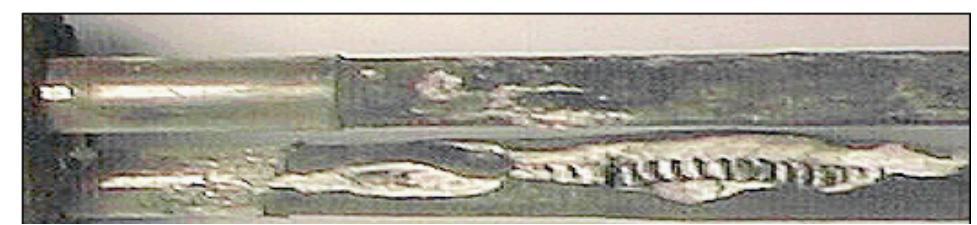
Split Sheath Fig. 6

Characterized by a split along the sheath or in the bend of the sheath. Could be caused by a small pinhole in the sheath which was enlarged due to chemical reaction. Inside the sheath there is a magnesium oxide powder that aids in the transfer of heat. If the powder gets wet, it will expand and cause the sheath to split. Notice the plastic sleeves do not show signs of melting. This indicates the damage to the element was not caused by excessive heat or voltage.
